Improved Concrete Cutting and Excavation Capabilities for Crater Repair

Phase 1

Final report

Prepared for Headquarters, Air Force Civil Engineer Center
Tyndall Air Force Base, FL 32403-5319

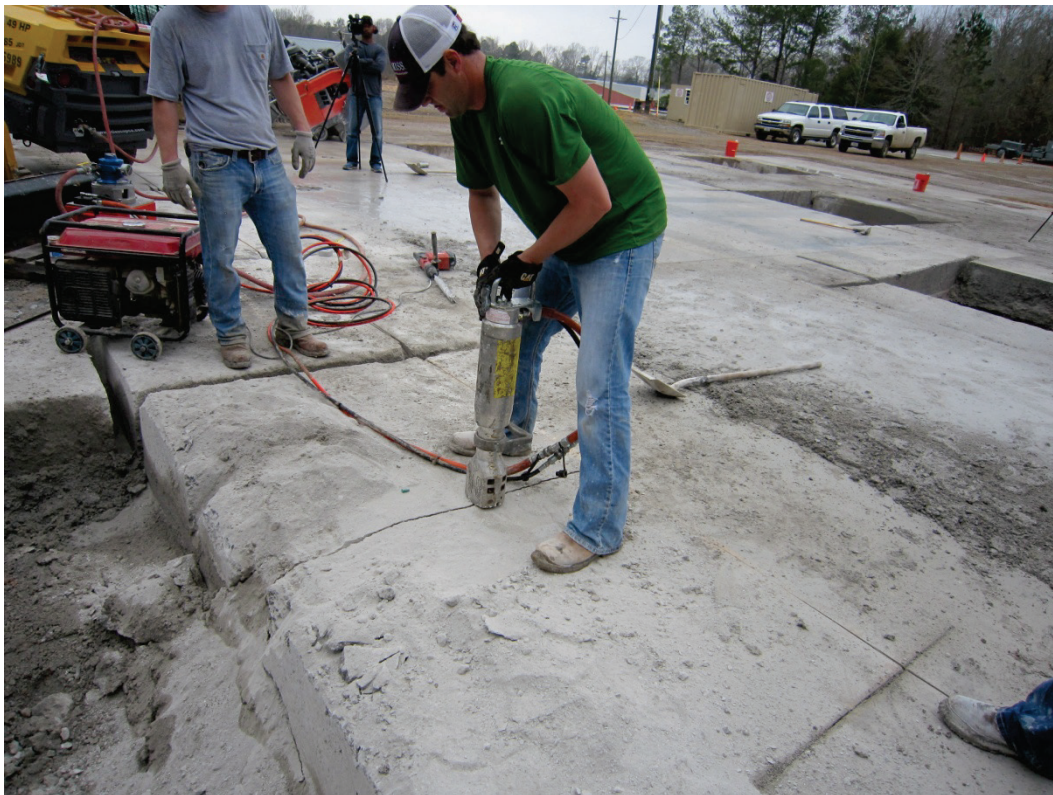
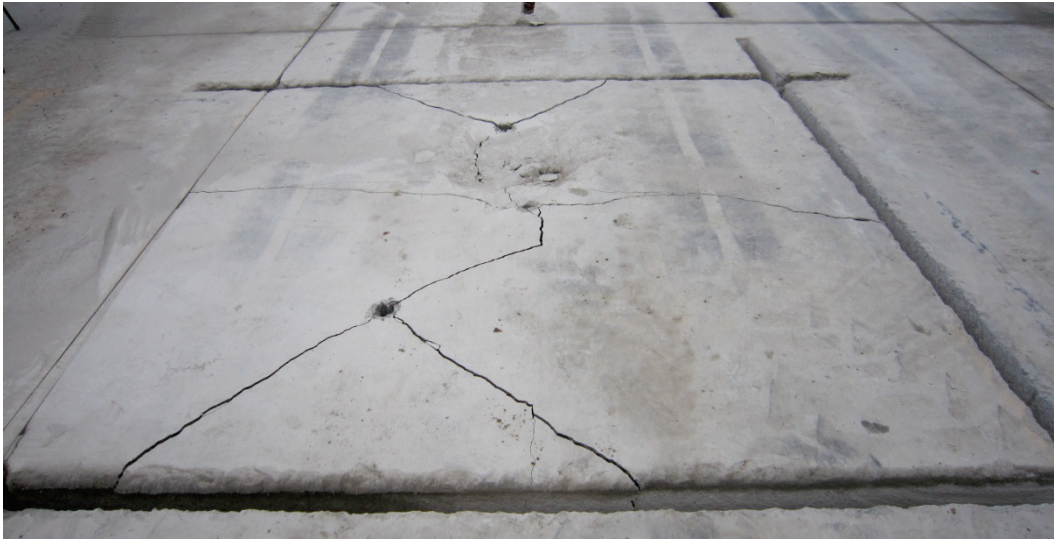
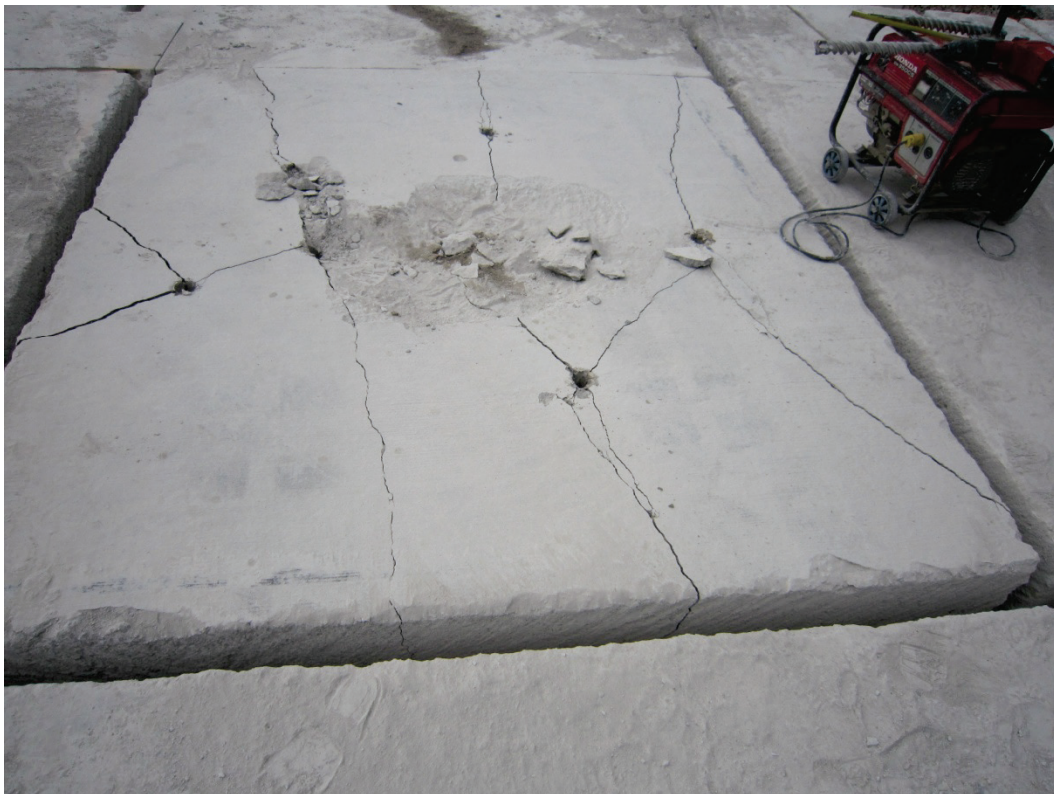
A rock splitter was also evaluated for its ability to break the thick PCC. The rock splitter was tested on two 18-in.-thick PCC slabs and one 24-in.-thick PCC slab. The rock splitter was used once in the 18-in. PCC in Crater 13 to break a half-slab into two pieces (Figure 35). This broke the slab into manageable pieces for the 430D backhoe to remove with ease. For the 18-in. PCC in Crater 14 (Figure 36), the rock splitter was used in three locations and turned 90 deg in each location to produce two breaks, which broke the slab into a total of six manageable pieces for the 430D backhoe to remove. For the 24-in. PCC slab, the rock splitter was used in five locations in Crater 17 (Figure 37). In each location, the rock splitter was turned 90 deg to produce two breaks, and the entire slab was broken into eight smaller pieces.

Figure 35. Remaining half slab broken in two pieces with rock splitter (Crater 13).

Figure 36. Rock splitter in three locations, resulting in six broken pieces (Crater 14).

Figure 37. Slab after five rock splitter instances (Crater 17).

The rock splitter drilling time shown in Table 22 reflects the time it took to drill one 18-in.-deep hole for the rod to be inserted in using a 1 $\frac{3}{4}$ -in.-diam drill bit. Often, it was necessary to drill more than one hole to break up the saw-cut slab into pieces small enough to be removed. The average time it

took to drill one hole was almost 13 min. The drilling was laborious and time consuming; however, the actual splitting of the concrete took less than 30 sec.

Rotating the rock splitter 90 deg after its initial split to try and crack the PCC in the opposite direction was successful about 50 percent of the time. During one instance, the rock splitter became jammed after turning it 90 deg, and the excavator hammer had to be brought in to break the PCC away so the rock splitter could be removed from the hole. The rock splitter had to be used in three different drilled holes of one 8.5-by 8.5-ft repair to successfully break up the 18-in.-thick PCC, totaling approximately 39 min just for drilling in one repair.

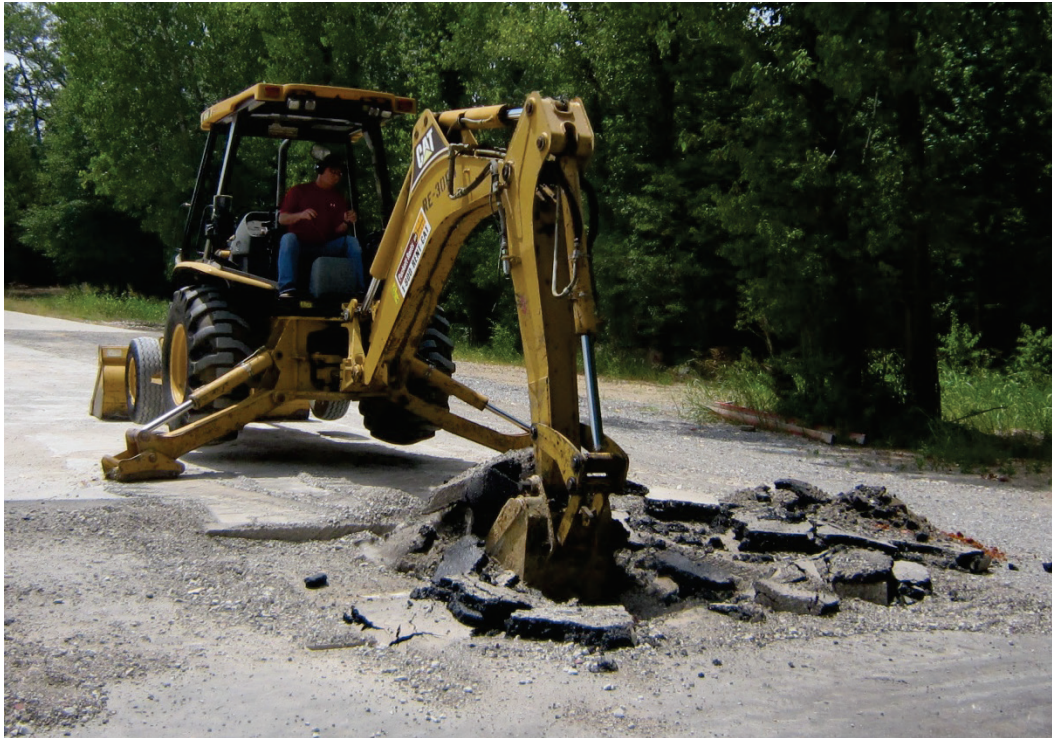
Figure 38. Removal of HMA with backhoe.

Two backhoes with similar capabilities were evaluated; one backhoe was equipped with a standard 24-in.-wide bucket, while the other backhoe was equipped with a rotating 24-in.-wide bucket with 6.5 in. long teeth. Both backhoes were each assessed on three PCC slabs. Only the backhoe with the standard 24-in.-wide bucket was tested on the HMA (Figure 38).

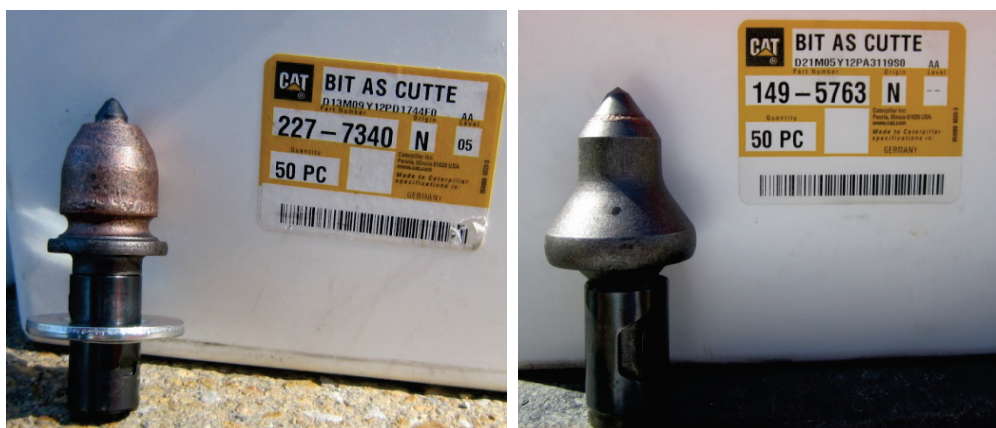
At the beginning of the tests, the standard concrete teeth were used on the Caterpillar wheel saws. However, the teeth tested on the wheel saws in the past and shown to be the best for crater repair purposes are Caterpillar's cold planer teeth (part number 149-5763). Caterpillar's concrete teeth (part number 227-7340) are typically sold with the wheel saws. The teeth are shown side by side for comparison in Figure 39. The concrete teeth were used on the first five craters tested, and the remaining craters were cut with the cold planer teeth. However, the wheel saw results presented in Table 22 are based solely on the testing with the cold planer teeth.

Figure 39. Concrete saw teeth (left) and cold planer teeth (right).

On average, the concrete teeth's cutting rate using the SW45 wheel saw was approximately 8 percent slower compared to the cold planer teeth in the 18-in.-thick PCC (0.98 versus 1.06 ft/min). On average, the concrete teeth's cutting rate using the SW60 wheel saw was approximately 20 percent slower compared to the cold planer teeth in the 18-in.-thick PCC (0.85 versus 1.02 ft/min).

The concrete teeth were also not as durable as the cold planer teeth. The production rates of the concrete teeth in the 18-in.-thick PCC decreased, on average, 66 percent from cutting one crater (three 9-ft-long lines) to cutting a second crater (an additional three 9-ft-long lines). The production rates of the cold planer teeth in the 18-in.-thick PCC decreased, on average, 29 percent from cutting one crater to cutting a second crater. The concrete teeth were not tested in the 24-in.-thick PCC.

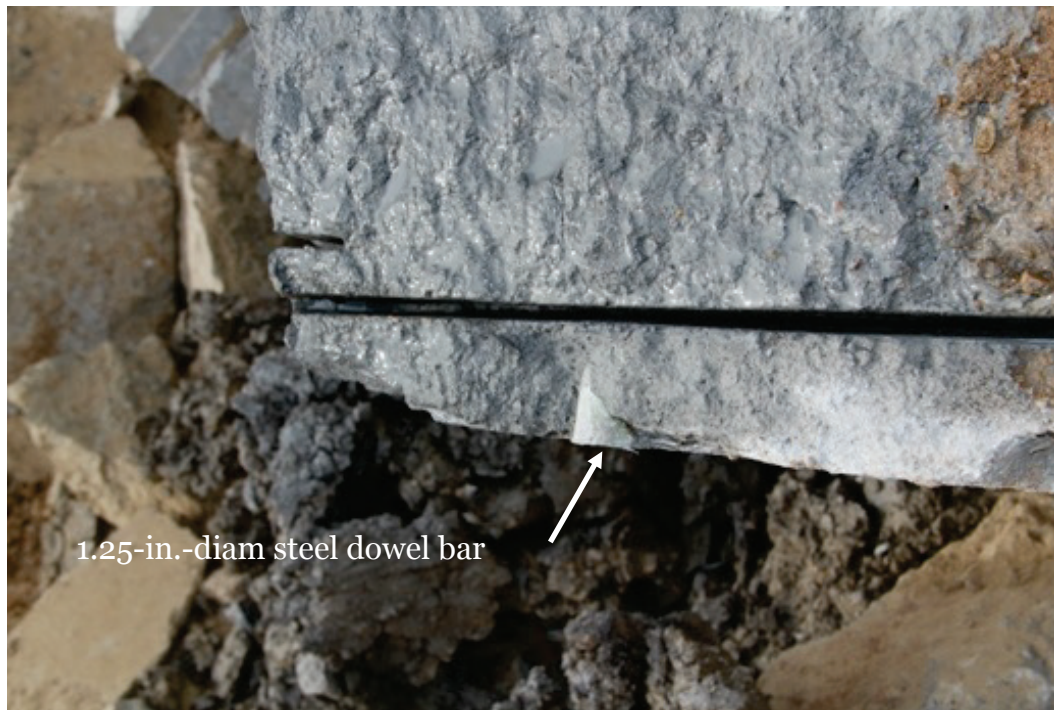
Figure 40. Utility chain saw cut through PCC and dowel rod.

The utility chain saw was not used on the test section, but it was evaluated on a large piece of PCC with an installed 1.25-in.-diam steel dowel rod. The concrete chain saw successfully sawed through the concrete and dowel. The production rate of the hand-held saw through only the PCC was approximately 0.065 ft/min. It took approximately 4.5 min to cut through the 1.25-in.-diam steel dowel rod. This is far from the goal of 1 ft/min; however, the saw did cut through the concrete and dowel rod successfully (Figure 40). The chains had to be tightened often during use but were still in good shape after sawing through the PCC and dowel rod as shown in Figure 41.

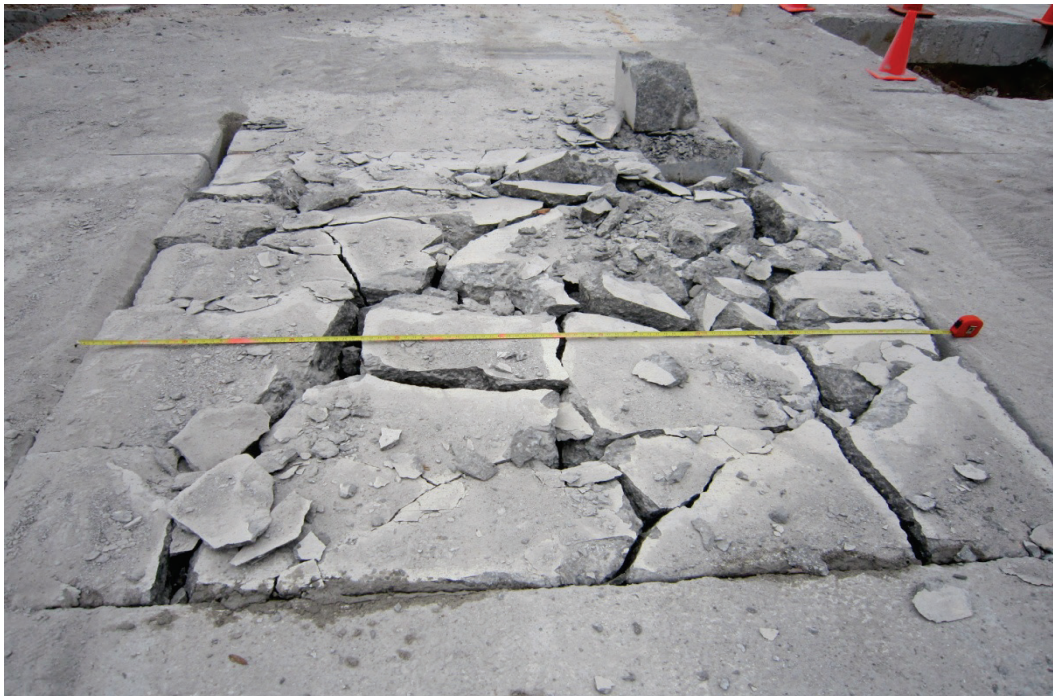
Each crater was broken into bucket-sized pieces, as shown in Figure 42, for efficient removal. Smaller pieces required more effort and increased the removal time. Larger pieces resulted in a faster removal time but were risky because the larger pieces were likely to be dropped and would damage the surrounding parent slab.

Figure 42. Example of broken slab with excavator with chisel hammer (Crater 5).

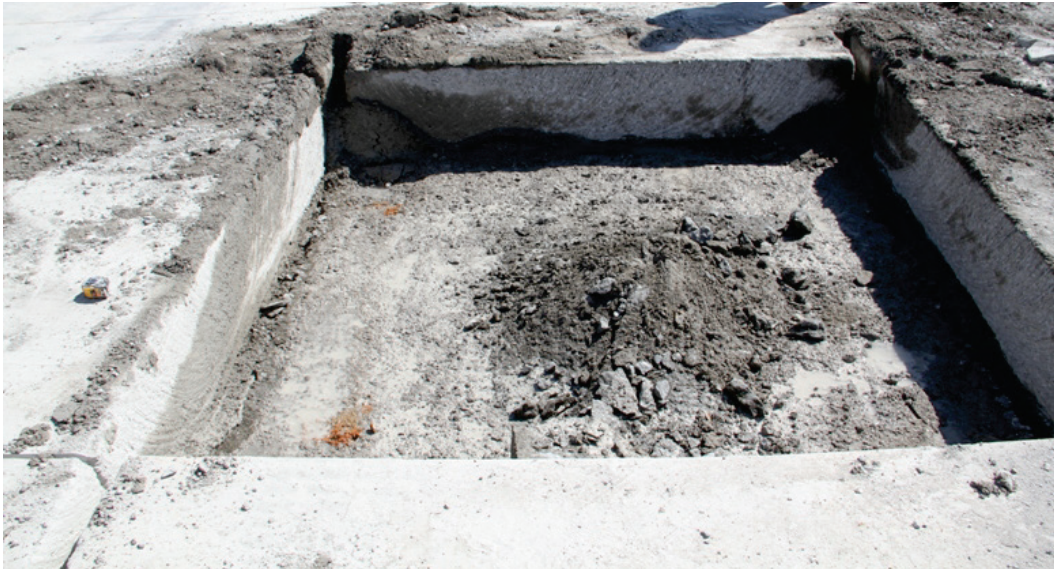
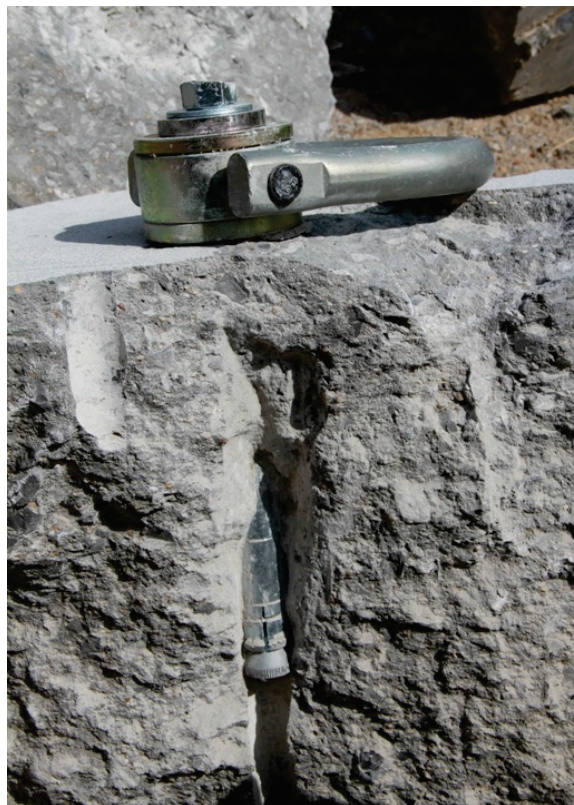
The PCC must be saw-cut full depth from corner to corner (at least on three sides) for the anchor pull-out method to be employed. The existing saw-cut doweled joints were cut to only approximately 17 in. of the 18-in.-thick PCC. Two of the three repairs tested with the anchor system were saw-cut using the SW60 wheel saw to ensure the PCC was cut full depth. Every 8.5- by 8.5-ft repair required at least four drilled holes with one relief cut down the middle, with each created using a wheel saw. Table 22 presents the average time it took to drill one hole, about 3.5 min. Approximately 14 min was spent drilling holes for one PCC crater removal. The remainder of the installation process of anchor placement, attaching shackles, tightening screws, and attaching straps, was also slow and cumbersome. The machinery tested, front-end loader (Figure 32), forklift (Figure 33), and excavator (Figure 34), were each able to lift half of a slab (two drilled anchors). Figure 43 shows the repair area after all PCC was removed using anchors. Figure 44 shows an installed and deployed anchor in a broken piece of PCC.

Figure 43. Repair area after slab was pulled out by the anchor system technique.

Figure 44. Deployed anchor in broken PCC.
